# Landsliding on the south east coast of the Isle of Wight: nature, characteristics and causes

Cole, G. (2013) 'Landsliding on the south east coast of the Isle of Wight: nature, characteristics and causes', The Plymouth Student Scientist, 6(2), p. 124-176.

**Grant Cole**

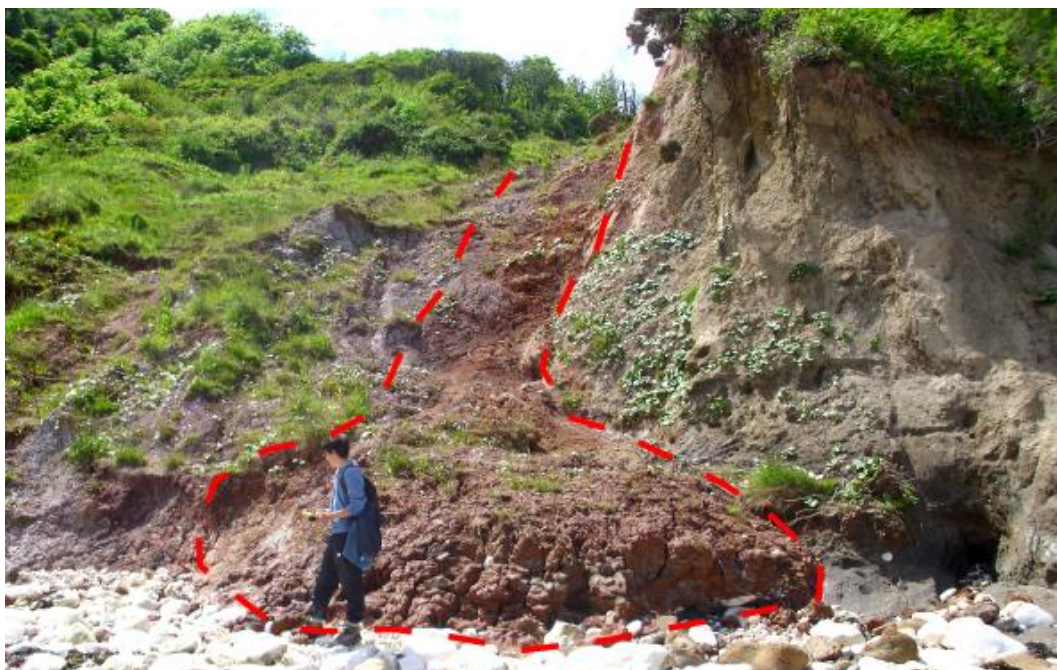
**Figure 3.2** Flow type landslide (6) in Whitecliff Bay (south), person for scale.

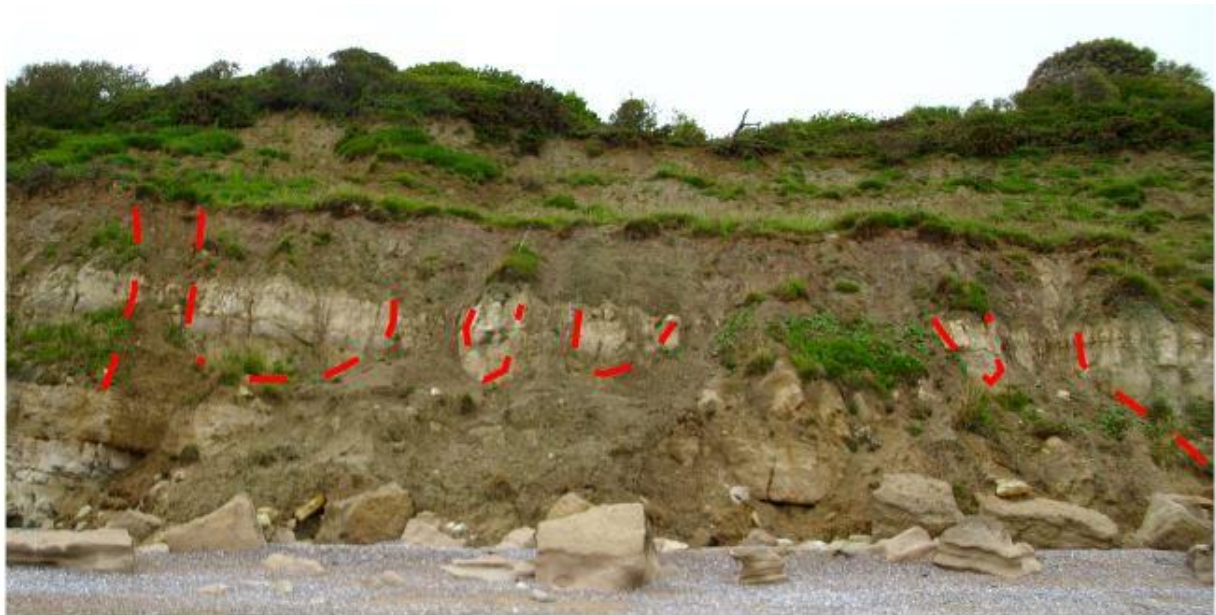
**Figure 3.3** Complex landslide with main type of movement (25) being flow type (Whitecliff Bay).

The Fall type landslides seen at Culver Down (Whitecliff) (Figure 3.1 & photo 3, Figure 3.12) show an accumulation of rocks at the base of the cliff / slope, which can vary in size (see landslide inventory; appendix C). The flow type landslides in Whitecliff Bay have a typical channel shape to them which then expands at the front in a lobate structure (Figure 3.2). Complex landslides with flow as the main movement types are similar but due to there being many converging flows the lobate form is lost for this particular landslide (Figure 3.3).

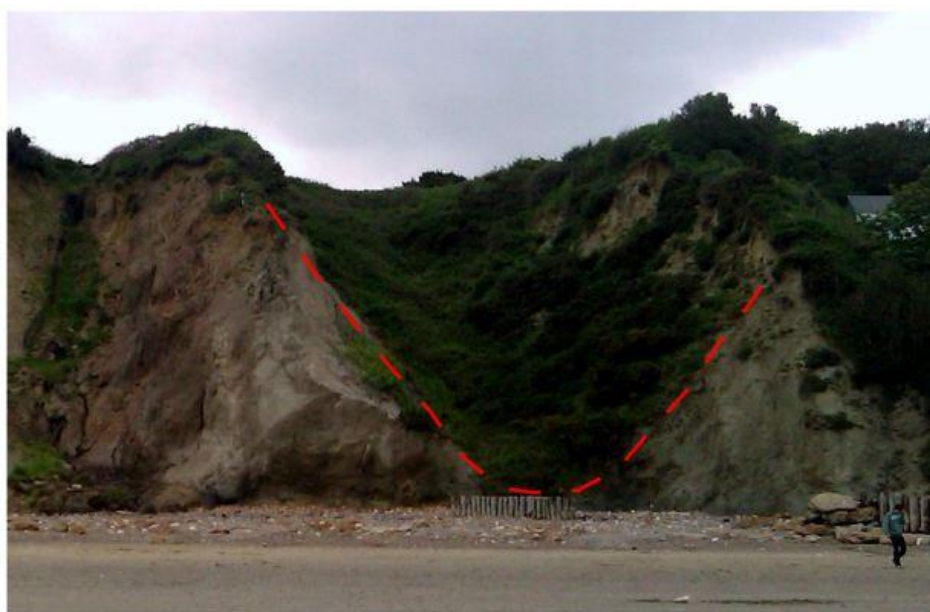
**Figure 3.4** Cross-sectional shape of a Translational (planar) landslide (16) in Whitecliff Bay (south).

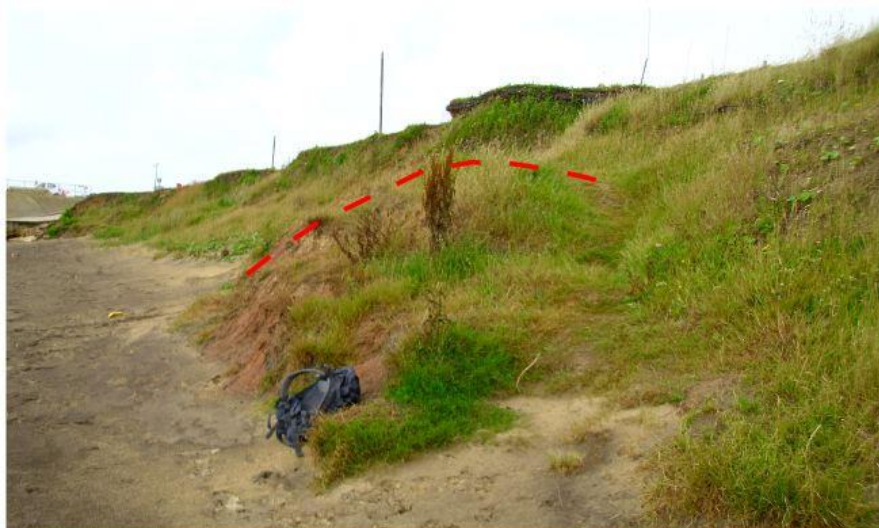
**Figure 3.5** Shallow single rotational landslide (1) at Yaverland. 40L back pack for scale.

The single rotational slides in Sandown Bay have a similar form to the ones in Whitecliff with a mound shape created at the front of the landslip (Figure 3.5) and a distinct back scar as seen on a complex landslide that has a rotational slide as the main movement type (photo 9, Figure 3.11).

The single rotational slides in the area show typical hummocky features (Figure 3.5) caused by the rotation of the displaced mass along a curved rupture surface (Cruden and Varnes, 1996). These hummocks were also picked out by the profiles (Figure 3.9), shown by the convex part of the profile. The single rotational slides are shallow failures when cliff heights are relatively low but get increasingly deeper seated with larger run outs and offsets as cliff height increases (Figure 3.18-3.21). There is a strong relationship in the data shown by the  $R^2$  values but the strongest relationship can be made between cliff height and vertical offset as there is only about a 10% chance that other factors are causing this relationship (Wheeler et al. 2004). This is similar for cliff height and total length of the landslides, as there is only about a 26% chance that this relationship occurred by other factors. This is understandable as the cliff height will control the amount of accommodation space available and thus the size of the mass that fails in a landslide (Jenkins et al. 2011). The weakest relationship is between cliff height and horizontal offset as there is a much greater chance that other factors such as the lithology are influencing this relationship (about 33%). The majority of the landsliding in the area is complex in nature, which is probably due to the great variation of lithology over the entire area and the complex physical properties of the materials which is highlighted by the previously discussed red cliff complex landslide. The main movement of this landslide is believed to be rotational as the toe area of the displaced mass shows rotation and that ponded water has developed behind the toe of the landslide, which is typical evidence of a rotated block as the block is usually backward tilted creating a depression for water to pond (Varnes, 1978). However the complexity

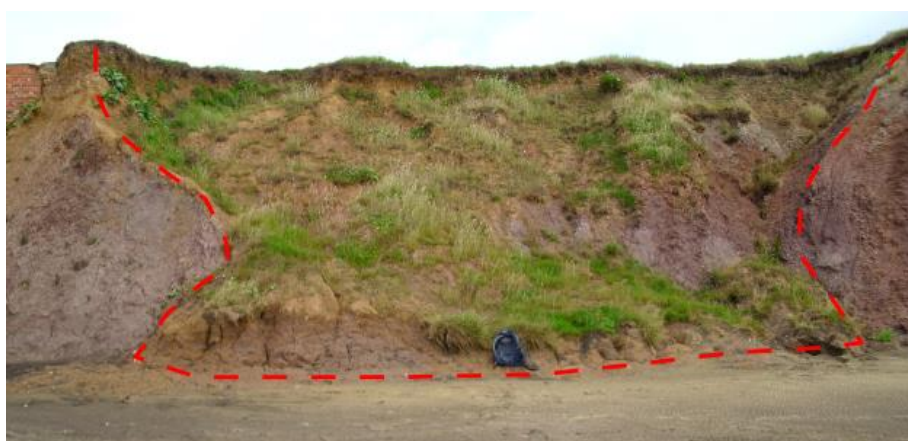
**Figure 3.6** Shallow Translational (planar) landslide in Sandown Bay, failure occurring near top of cliff (2). 40L back pack for scale.

The translational (planar) slides in Sandown Bay are different to the ones in Whitecliff Bay (Figure 3.6); the U-shape form is lost, except possibly at the back of this landslide where the failure originated from, they also have a mass of material accumulating at the front of the landslide that has not rotated.

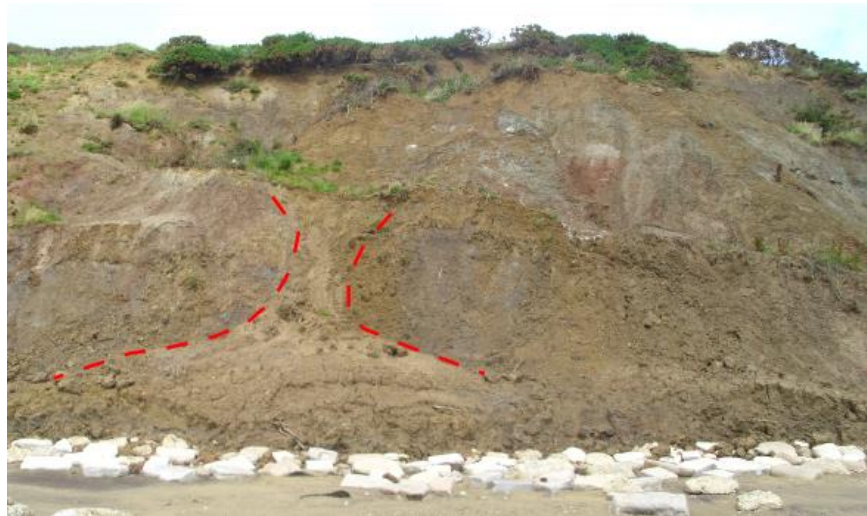
**Figure 3.7** Flow type landslide in Yaverland (6).

displaced material accumulating at the front of the landslide, spreading out and forming a lobe (Figure 3.7).

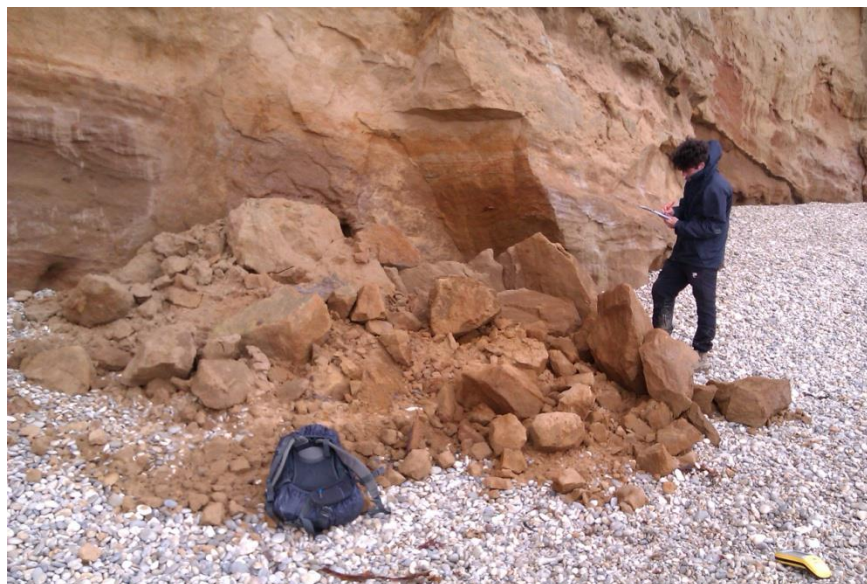
**Figure 3.8** Fall type landslide at Red cliff (19). Person for scale and 40L back pack.

The fall type landslides in Sandown Bay are similar to that in Whitecliff Bay showing an accumulation of rocks at the base of the cliff (Figure 3.8 & 24, Figure 3.11).

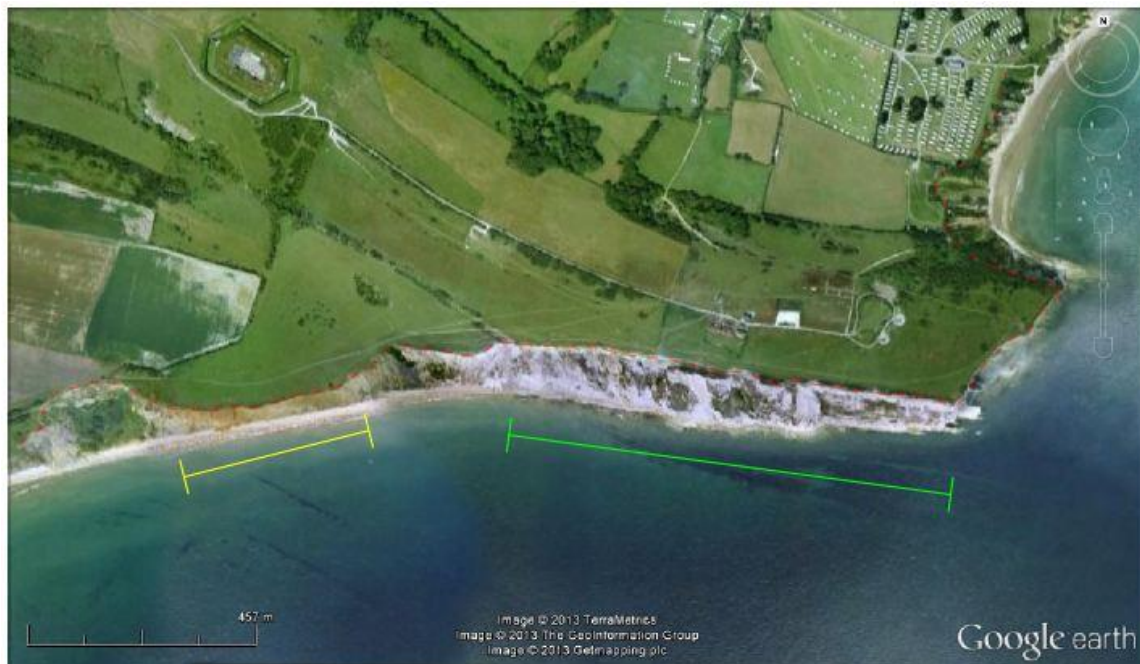
**Figure 4.1** Google Earth imagery showing the outline of the cliffs at Red cliff and Culver Down. Cliff outline is highlighted by red dotted line. Yellow bar shows the location of the succession of sands (Ferruginous sands) involving the lithologies 15 – 19 (Figure 3.11). Lime bar shows the location of the chalk cliffs (Chalk group) involving the lithologies 30 – 34 (Figure 13.1).

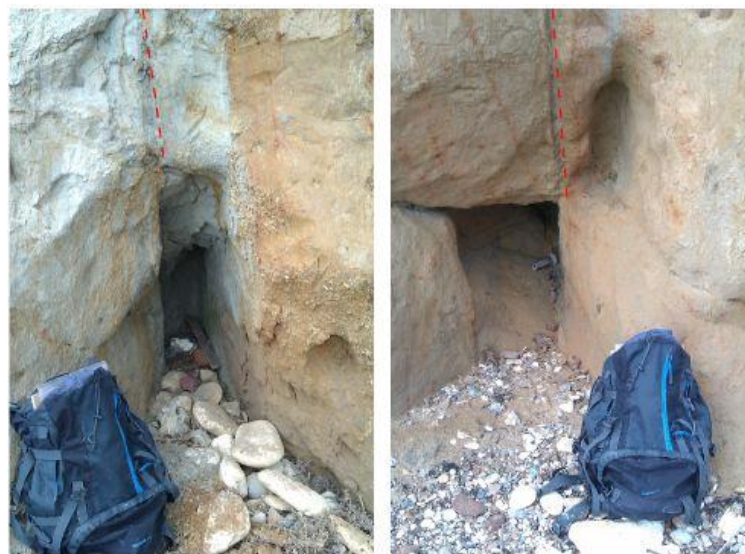
**Figure 4.3** Gullies forming where there is a thicker clay horizon, located left of the red dotted line.

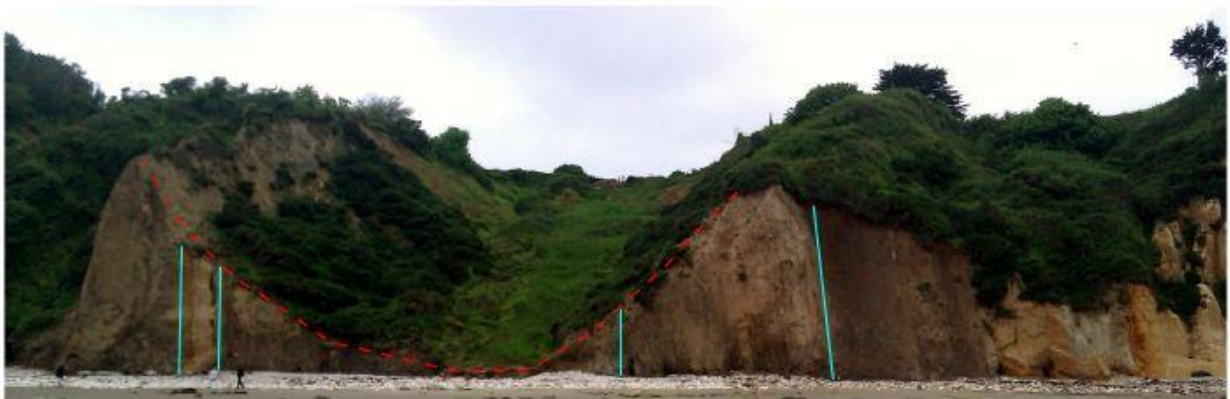
**Figure 4.4** Complex landslide (9, Figure 3.12) showing the relationship between bedding surfaces and the extent of the landslide.

1982). However, landslides 11, 14, 15, 16 and 17 (Figure 3.12) are all occurring where bedding surfaces (contacts) occur and thus they could be making the slopes more susceptible to landsliding. Landslide 9 (Figure 3.12 & 4.4) shows that the deepest part of the landslide is in the centre implying that the failure occurred towards the centre of the landslide and thus away from the bedding surfaces, showing that they may have had little influence on this landslide.

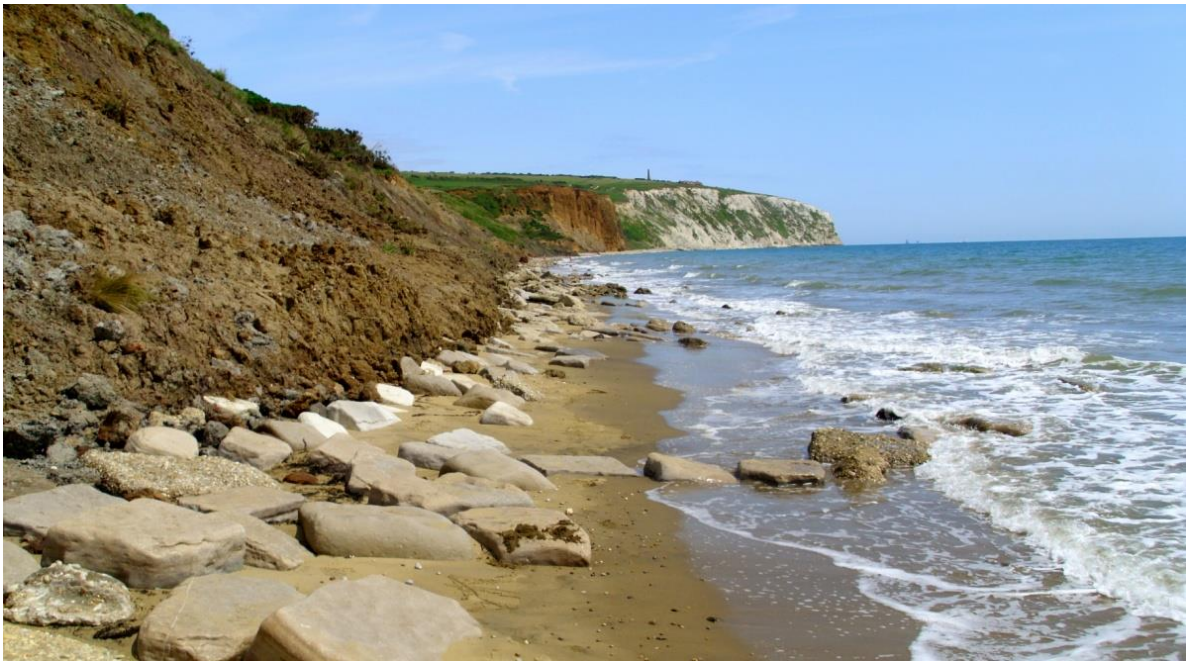
**Figure 4.7** Evidence of the sea reaching the base of the cliffs near high tide.

At high tide the sea reaches the base of the cliffs in most of the area (Figure 4.7) except in parts of Yaverland especially from the succession of sands (Ferruginous Sands) up until the chalk. The effect that the sea will have will be to remove material from the toe of a landslide. This then reduces the stability of the slope and can promote further recession through landsliding (Lee et al. 2001). The removal of material from the base of a slope also causes the slope to steepen which is argued by Wolters and Muller (2008) as being the critical factor for increasing slope instability. However, the deposition of material at that base of the slope provides protection from wave run-up and thus erosion only occurs when the debris has been removed (Lee, 2008). This then could also explain why the chalk group has receded the least, as the falls will deposit material at the base of the slope providing a natural protection to marine erosion. This effect will be diminished in soft rock cliffs (majority of the study area) as the displaced material deposited at the base of the cliff / slope will be highly disturbed and in a fully softened state which will mean it can be easily eroded (Castedo et al. 2012). Thus, this will have the effect to provide the condition for continuous landsliding as marine processes will be able to easily remove material from the base of slopes as most of the area consists of soft rock cliffs (Figure 3.11 & 3.12).
